**Docket No. 217 – Development and Management Plan Inspection**

Northeast Utilities Service Company Certificate of Environmental Compatibility and Public Need for the construction of a 345-kV electric transmission line and reconstruction of an existing 115-kV electric transmission line between Connecticut Light and Power Company's Plumtree Substation in Bethel, through the towns of Redding, Weston, and Wilton, and to the Norwalk Substation in Norwalk, Connecticut.

**Date:** October 27, 2005

**Location:** Norwalk Substation Expansion

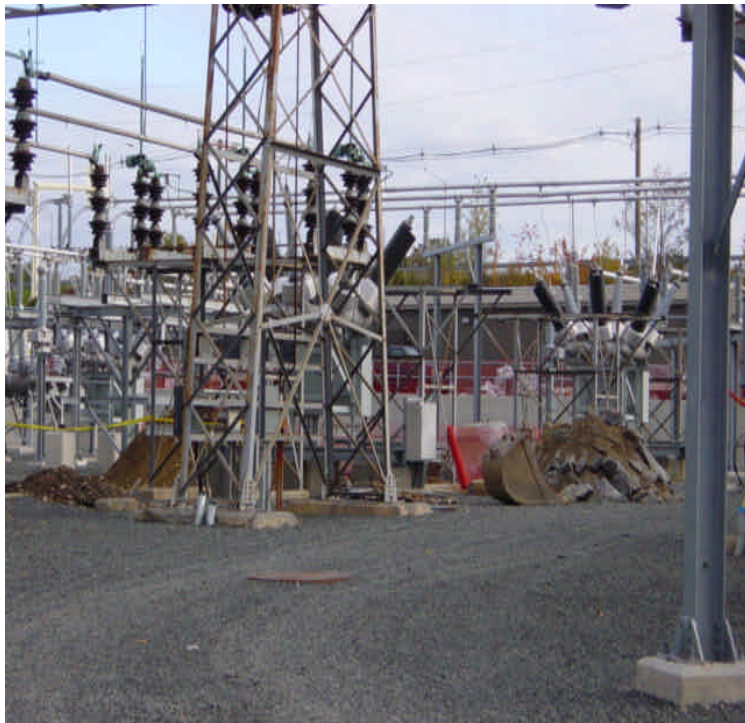
**Norwalk Substation: Photo on the left shows some excavation/work ongoing in the yard near the GIS building. Photo on the right shows a catch basin near the corner of the GIS building where sediment has built up either on the filter fabric or within the basin. 10/27/05**

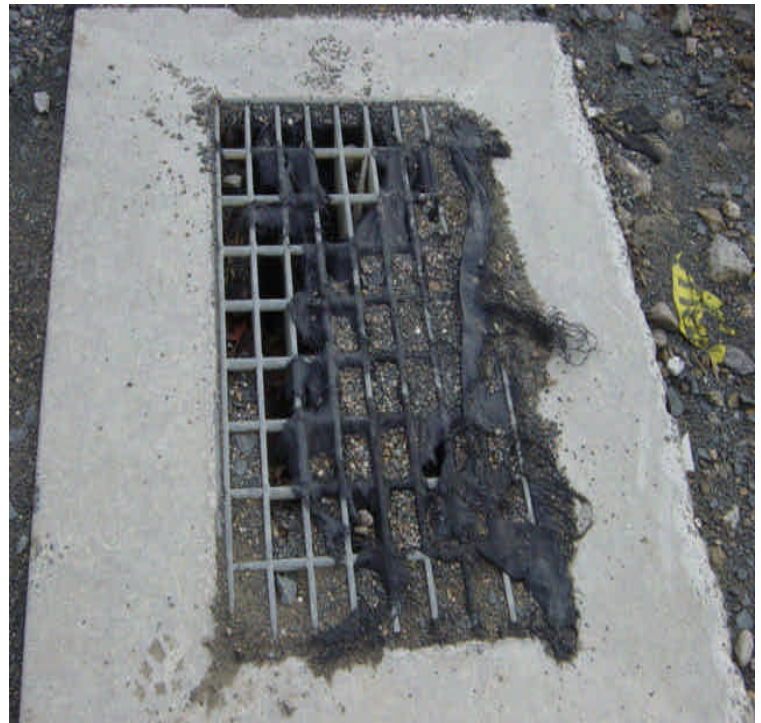
Areas of Inspection	Observation	Recommended Action
<p>Erosion and Sediment Controls (includes inspection within 24 hours of a storm event)</p>	<ul style="list-style-type: none"> <li>- A catch basin at the southern corner of the GIS building has sediment accumulating either on the fabric within the grate or within the basin itself. 10/27/05</li> <li>- Sedimentation from the access road off the Rt. 7 ramp was noted in the vegetated perimeter swale but it did not leave the site. 9/21/05-10/27/05</li> <li>- Large amounts of stormwater from the Rt. 7 ramp as well as portions of the perimeter of the site continue to flow to the inlet but the vegetation and stone aid filtration. 8/19-10/27/05</li> <li>-The overflow channel had some accumulated sediment at the edge of the river due to the flooding. 10/27/05.</li> <li>- Erosion controls at the turning structure work area need repair/ 10/27/05</li> </ul>	<ul style="list-style-type: none"> <li>- Clear the fabric of sediment and replace protective/control measures. If the sediment has reached inside the basin, clean out any buildup. 10/27/05</li> <li>- Sedimentation and gravel remain contained within the swale. The access road will be paved eventually which will remove the problem. Continue to monitor area until final stabilization. 9/21/05-10/27/05</li> <li>- Continue to monitor the area and the silt fence could be removed as the stone is now in place. 10/27/05</li> <li>- Sediment may need to be removed by hand here in order to restore the original capacity of the channel. This may be done during the adjacent work. 10/27/05</li> <li>- Repair the silt fence as restoration activities begin in the work area, and maintain them until final stabilization. 10/27/05</li> </ul>

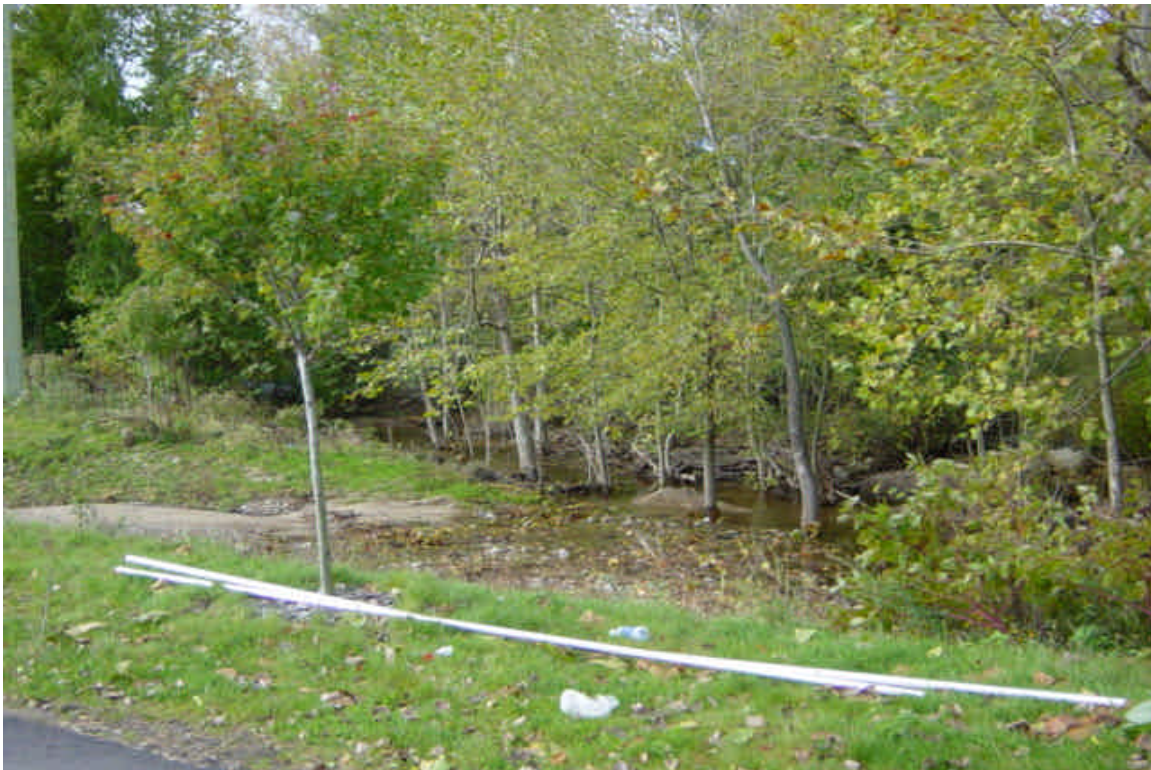
<p>Inland Wetland and Watercourse encroachment and mitigation</p>	<ul style="list-style-type: none"> <li>-The 345kV work area will be restored and materials removed once it has dried out some more. Sediment was noticed at the edge of the overflow channel and the river. 10/27/05</li> <li>- Sheet piling remains intact at the channel entrance as a temporary, partial dam for the work. 10/5-10/27/05</li> </ul>	<ul style="list-style-type: none"> <li>- The remaining temporary fill and jersey barriers will be removed and the site restored to its original condition. 10/27/05</li> <li>-Accumulated sediment will likely need to be removed from the channel at this time. 10/27/05</li> </ul>
<p>State species of concern, threatened and endangered species</p>	<ul style="list-style-type: none"> <li>- No species of concern are located in this area of construction.</li> </ul>	<ul style="list-style-type: none"> <li>- N/A</li> </ul>

**View of the overflow channel at the edge of the river. Sediment has built up here and may need to be removed to retain original capacity of the channel. 10/27/05**

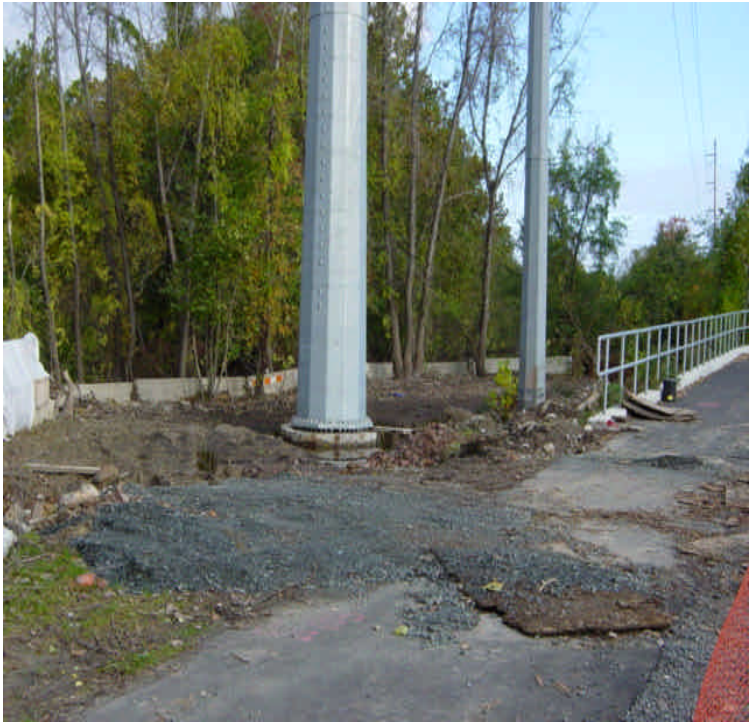
Photo on the left shows the work area near the recently installed 345kV turning structure. Photo on the right shows an additional view of the work area with the jersey barriers and fill to be removed when conditions dry out. 10/27/05.

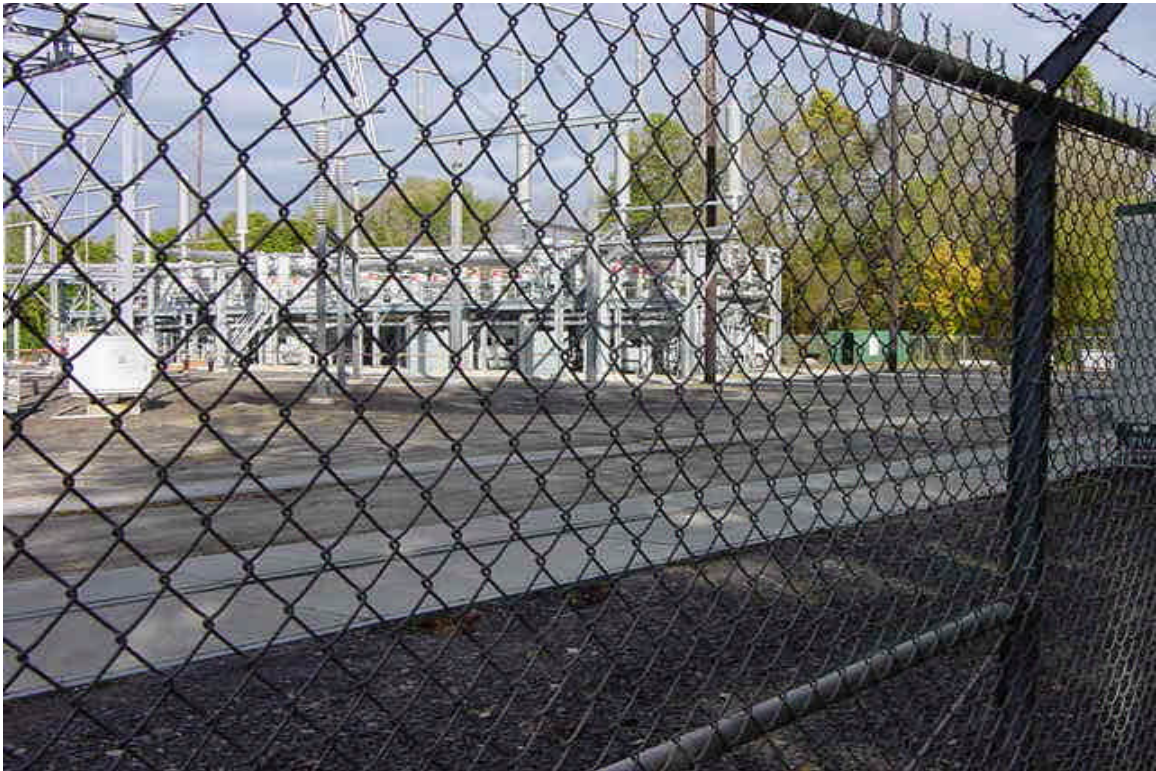
Plumtree Substation: No additional civil or earth disturbing work is ongoing at the yard at this time. 10/27/05.
